# City of Wilmington Pedestrian Safety Study

Wilmington Pedestrian Audit

*Top 10 Intersections*

*July 14, 2023*

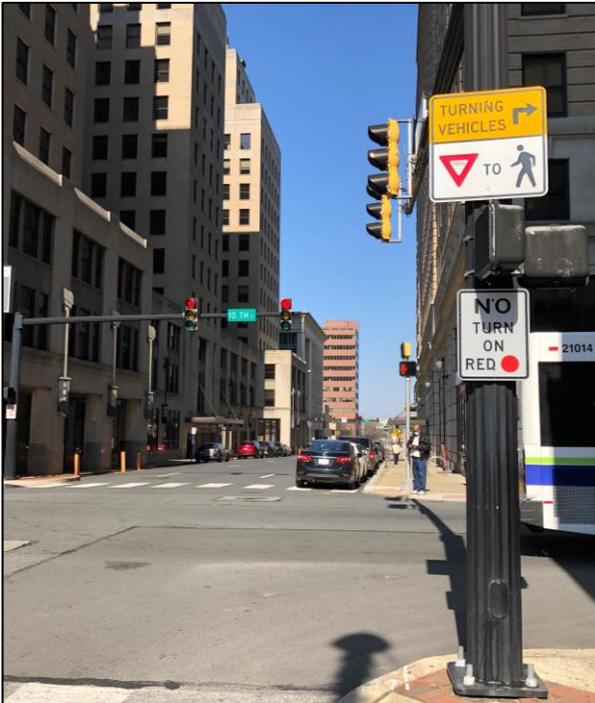
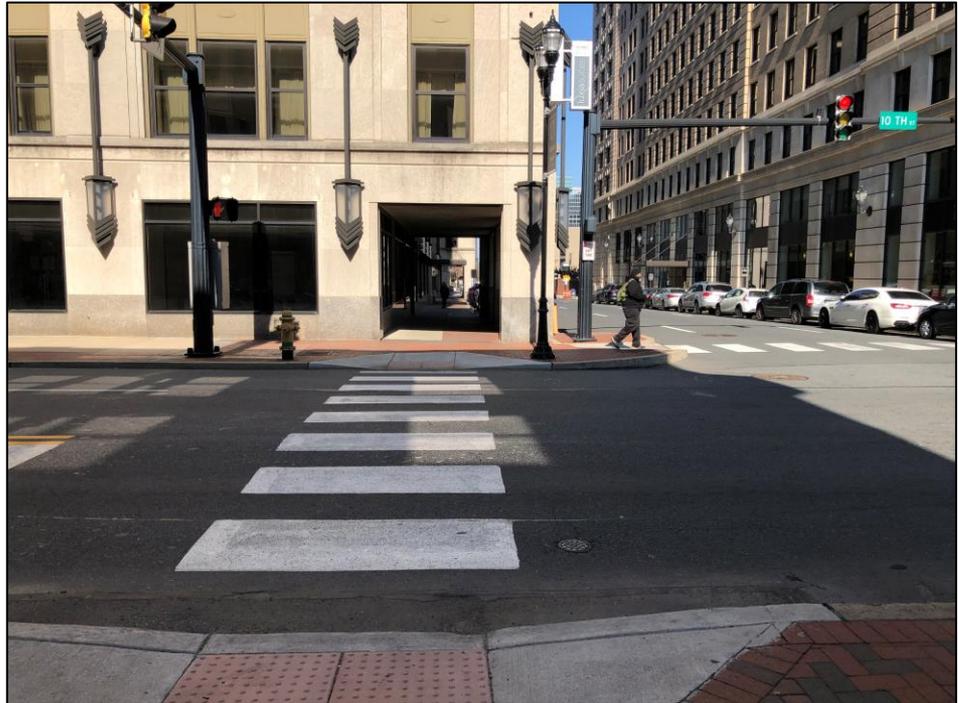
# 10<sup>th</sup> Street at Orange Street

- Orange Street is a one-way northbound road
- 10<sup>th</sup> Street is a two-way road
- NBR turn on red prohibited
- Intersection lighting adequate
- Wilmington Transit Corridors Project
  - Curb ramp and sidewalk improvements on SE corner of intersection

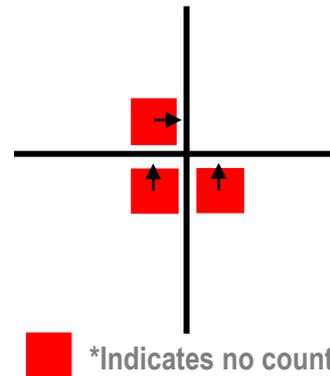
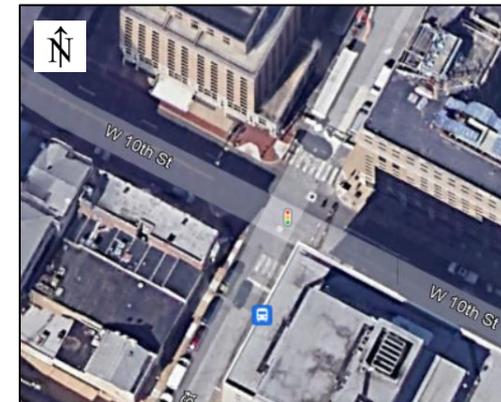
- Observed pedestrians crossing against the signal on all legs
- East leg does not currently have crosswalk striping
- There are three existing ped heads that don't have countdowns
- Bus stop observed on south leg

- Upgrade three existing pedestrian heads with no countdowns to include countdowns
- Install crosswalk striping on east leg of intersection
- Install TURNING VEHICLES YIELD TO PEDS signs (R10-15) adjacent to NB left-turn
- Consider Leading Pedestrian Interval (LPI) for west leg crosswalk

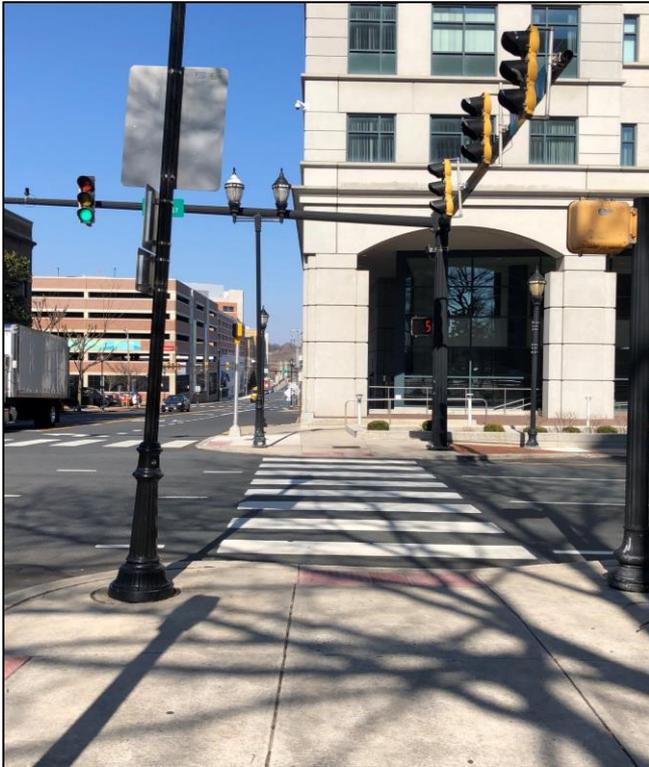
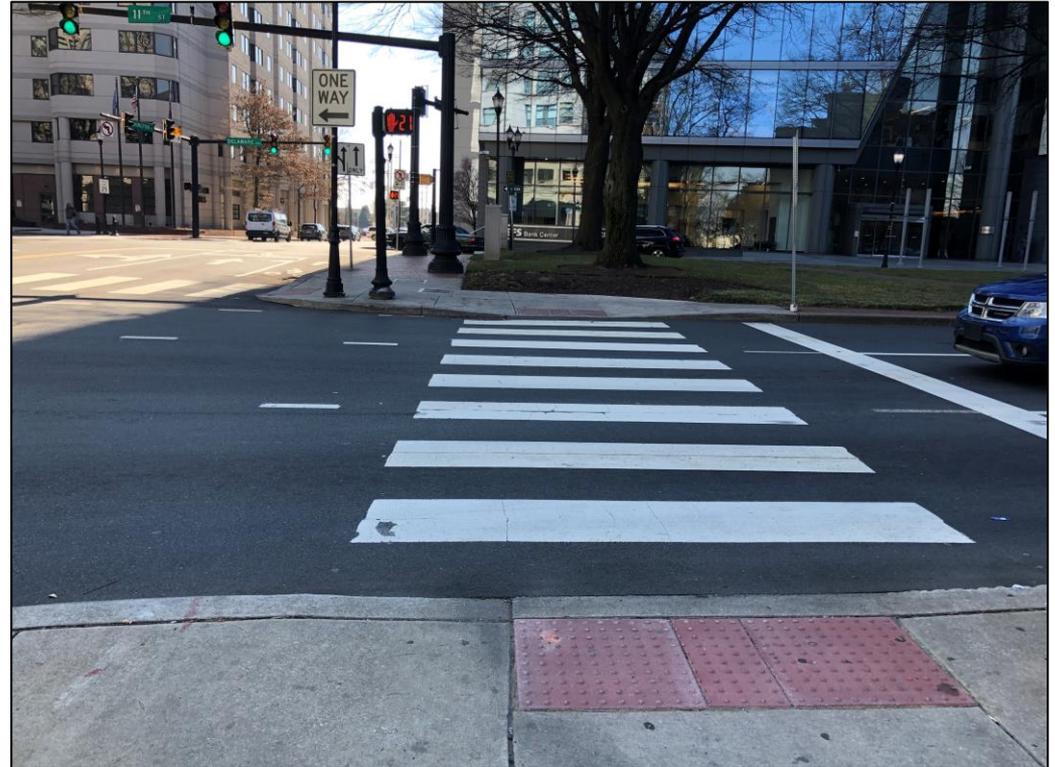
# 11<sup>th</sup> Street at Washington Street

- 11th Street is a one-way eastbound road
- Washington Street is a two-way road
- Intersection lighting adequate

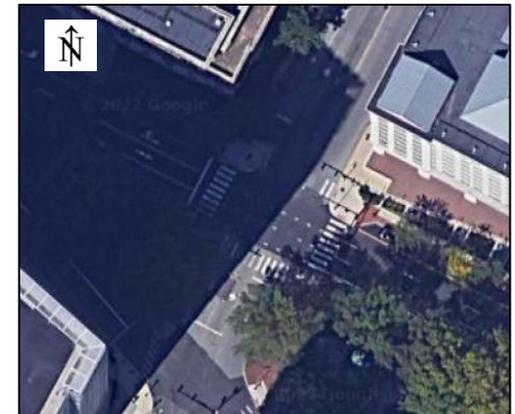
- Little pedestrian activity observed during site visit
- All pedestrian signal heads had working countdown displays
- Bus stops observed on north and east legs
- EB red light camera
- Right hand side sign assembly crooked

- Replace damaged sign structure at intersection
- Install TURNING VEHICLES YIELD TO PED signs (R10-15) where applicable
- Consider Leading Pedestrian Interval (LPI) for north leg crosswalk

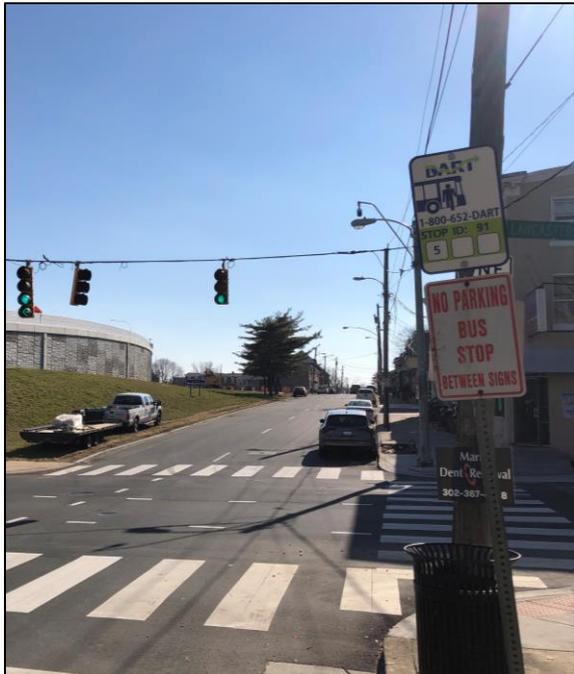
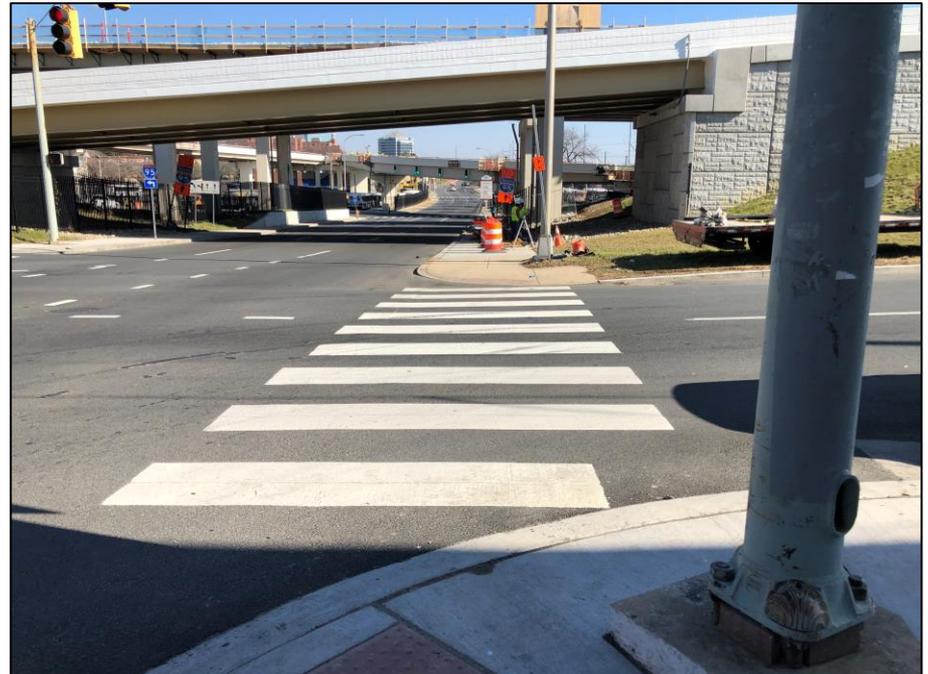
# Lancaster Avenue at Jackson Street

- Lancaster Avenue is a one-way eastbound road
- Jackson Street is a one-way southbound road
- Intersection is currently staging area and along a detour route for the Wilmington Viaduct Project
- Intersection part of 2018 HEP Study, Site E
- Intersection lighting adequate

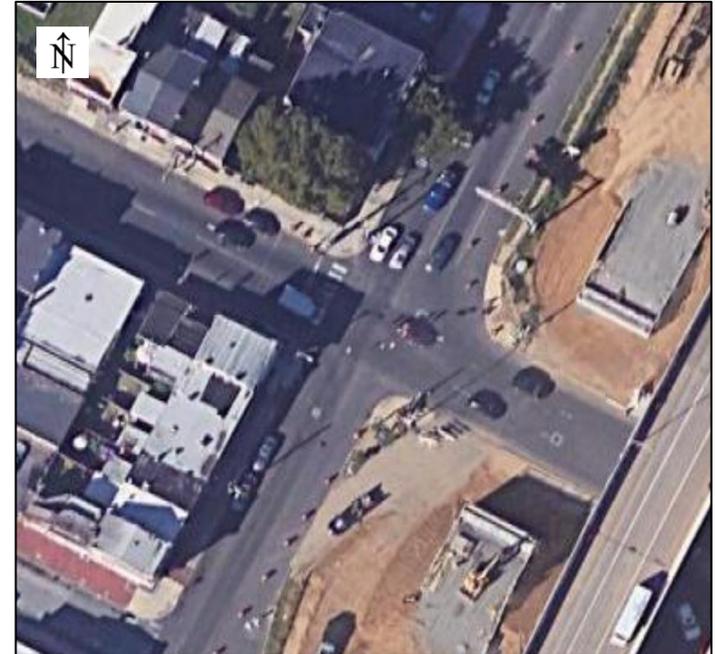
- 3 crashes involving EB right-turning vehicles striking pedestrians in the crosswalk
- 2 crashes involving SB vehicles striking pedestrians in the crosswalk (1 FATAL)
  - Fatal accident occurred on Saturday, November 5, 2011, at 6:58 PM; witnesses claim pedestrian ran out trying to beat the traffic
- 1 crash involving EB vehicle striking pedestrian in the crosswalk

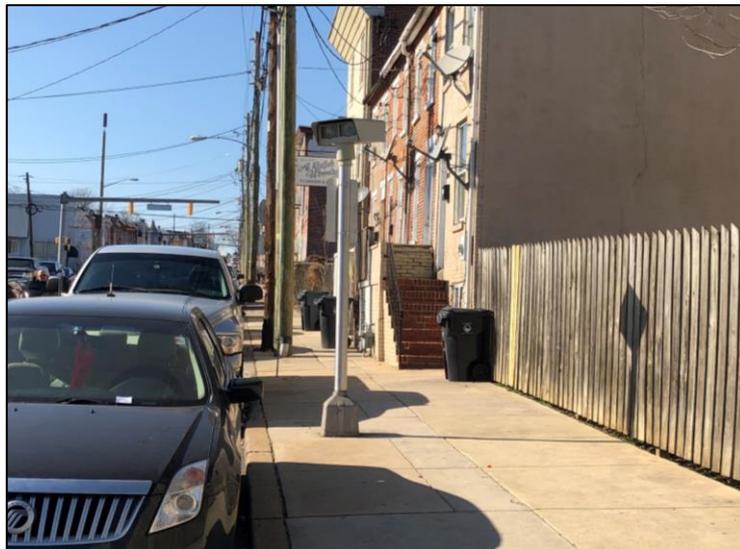
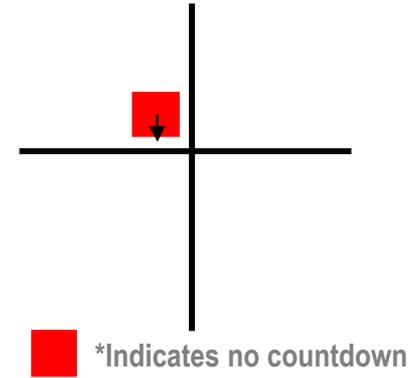
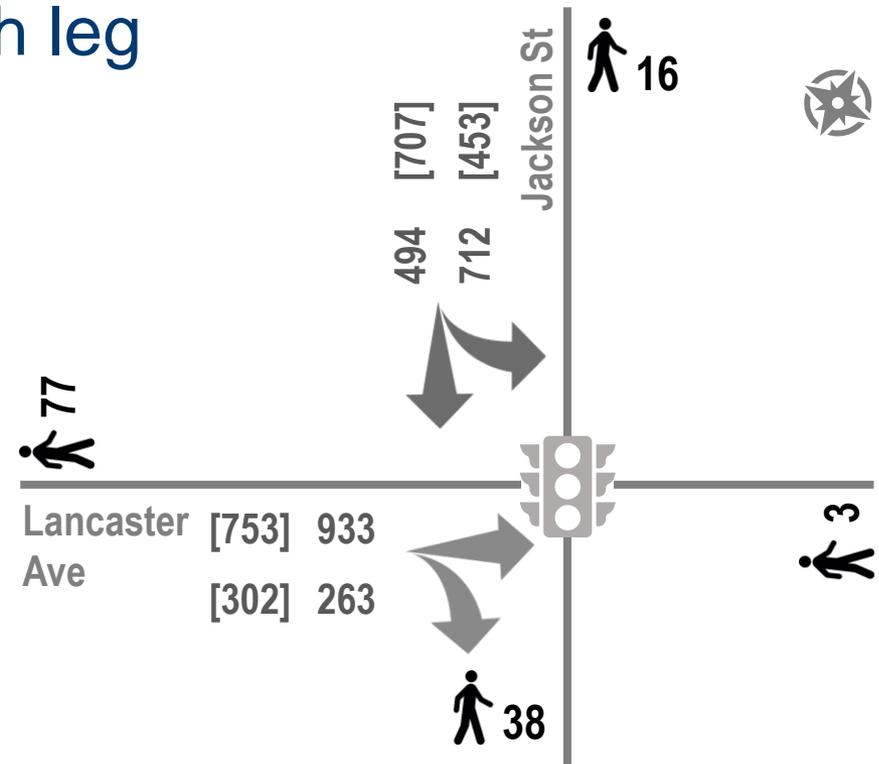
# Lancaster Avenue at Jackson Street

- No pedestrian crossing on the east leg
- There is one existing ped head that doesn't have countdowns
- Bus stop observed on north leg
- EB red light camera

- Upgrade existing pedestrian head with no countdowns to include countdowns
- Install TURNING VEHICLES YIELD TO PEDS (R10-15) adjacent to EB right-turn
- Per 2018 HEP, Site E study:
  - Install DO NOT ENTER (R5-1) sign (30"x30") on NW corner facing WB traffic
  - Replace DO NOT ENTER (R5-1) sign (30"x30") on SW corner facing WB traffic
  - Install crosswalks on the north leg (south leg crosswalk to be installed under contract #T201701401)
  - Refresh crosswalk on the west leg
  - Refresh turning tracks for SB Jackson Street
  - Install pedestrian countdown display on NW corner
  - Install pedestrian signal poles and countdown displays on SE and SW corners

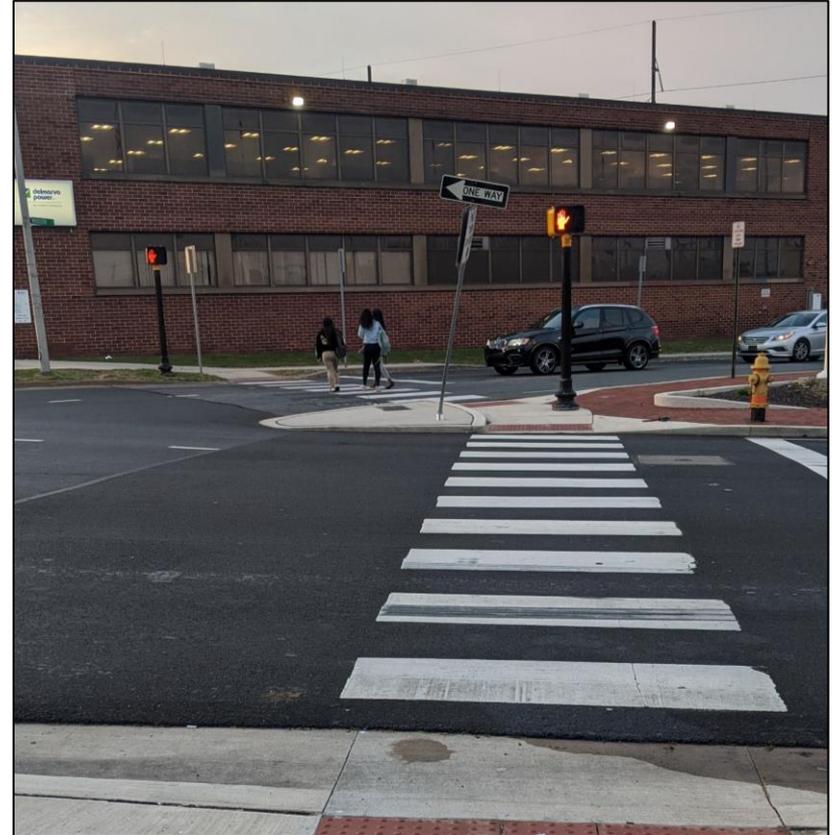
- MLK Boulevard is a one-way eastbound road
- Maryland Avenue is a one-way north eastbound road
- Madison Street is a two-way northbound/southbound road, at this intersection
- Intersection part of 2018 HEP Study, Site E
- Intersection is along a detour route for the Wilmington Viaduct Project
- Pedestrians were observed crossing against the signal
- Intersection lighting deficient

- Consider lighting improvements on the north leg
- Install TURNING VEHICLES YIELD TO PED signs (R10-15) where applicable
- Per 2018 HEP, Site E study:
  - Upgrade existing pedestrian heads with no countdowns to include countdowns
  - Currently in design
